Spy Pond Edge Protection and Erosion Control Project

Site Characterization Report

Town of Arlington

December 2016

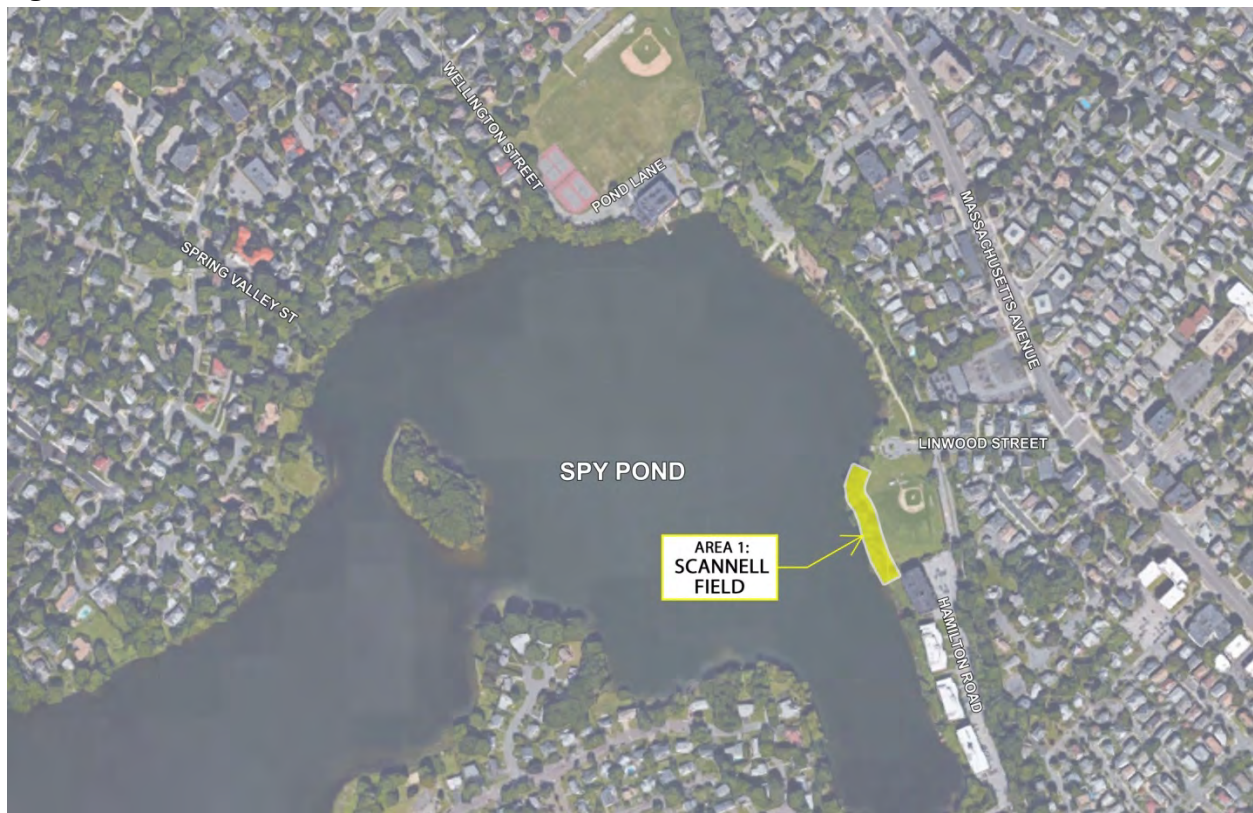
Figure 2 – Area1: Scannell Field

The majority of the area is in poor condition with dead and dying trees, exposed roots, unstable banks, extensive areas of eroding soils, and litter that will require a comprehensive approach to stabilization including control of the human activity that is at the root of the problem.

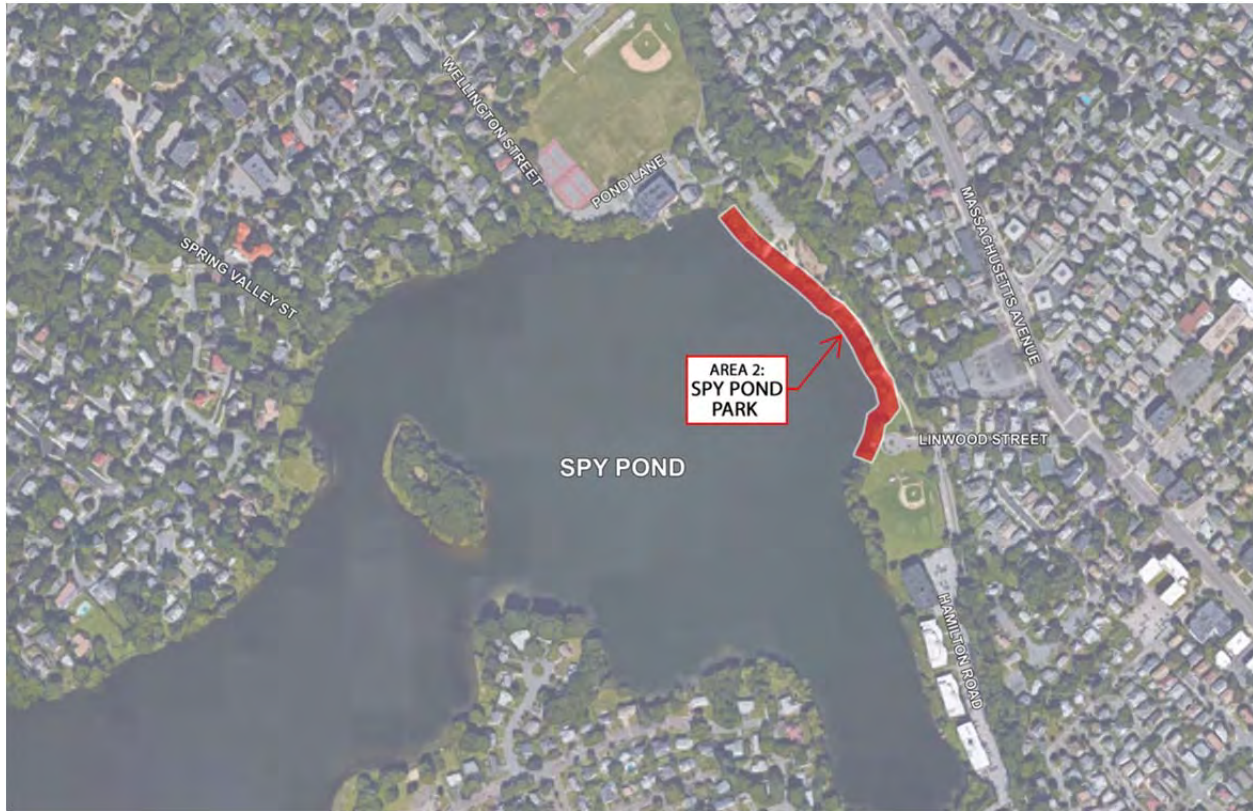
Figure 4 – Area 2: Spy Pond Park

For the most part pedestrians limit themselves to the defined pathways; however, desire lines do exist along the slope to the pond in a few locations between the boat ramp and the beach providing additional access to the water. These informal pathways eliminate stabilizing vegetation that lead to erosion and, consequently, sedimentation in Spy Pond.

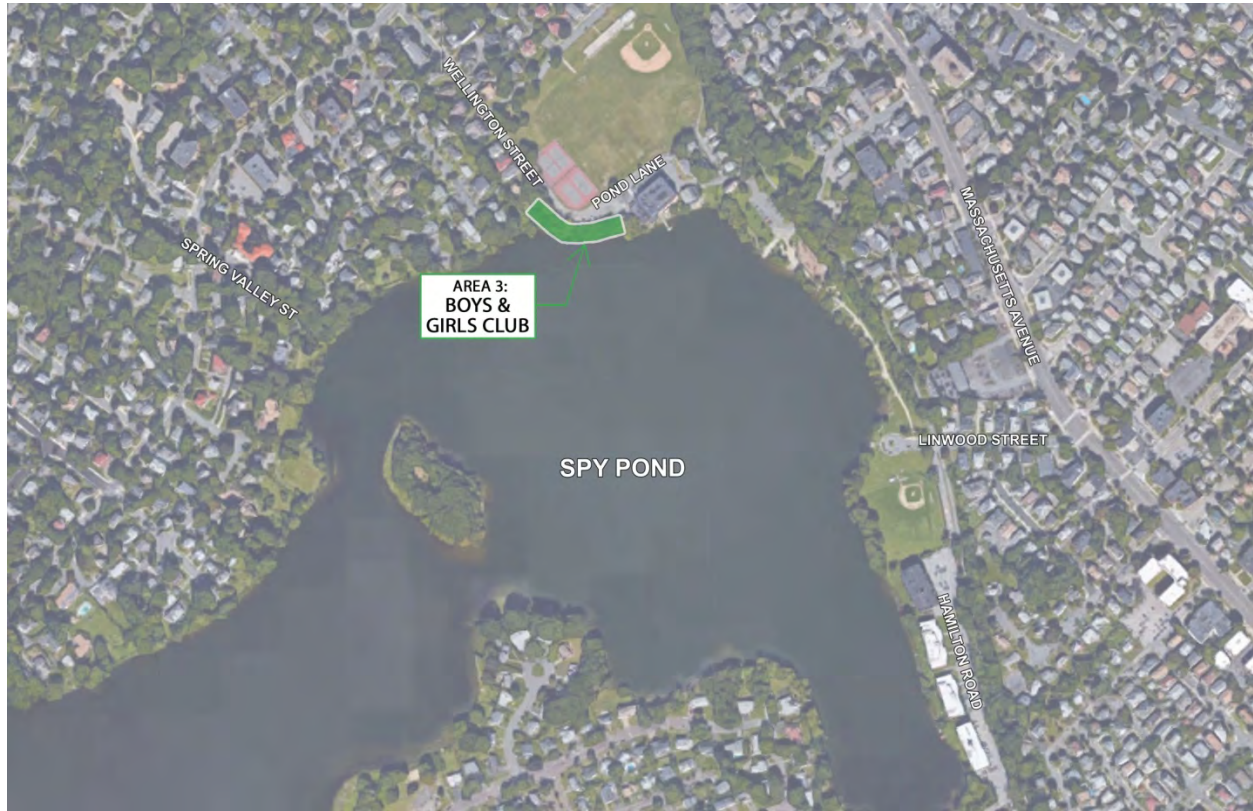
Figure 6 – Area 3: Boys & Girls Club

serves to provide habitat for small animals and birds, however, sediment from the uncontrolled pathways contributes negatively to the aquatic habitat. Any and all sediment that enters the water of Spy Pond continues to degrade the water quality.

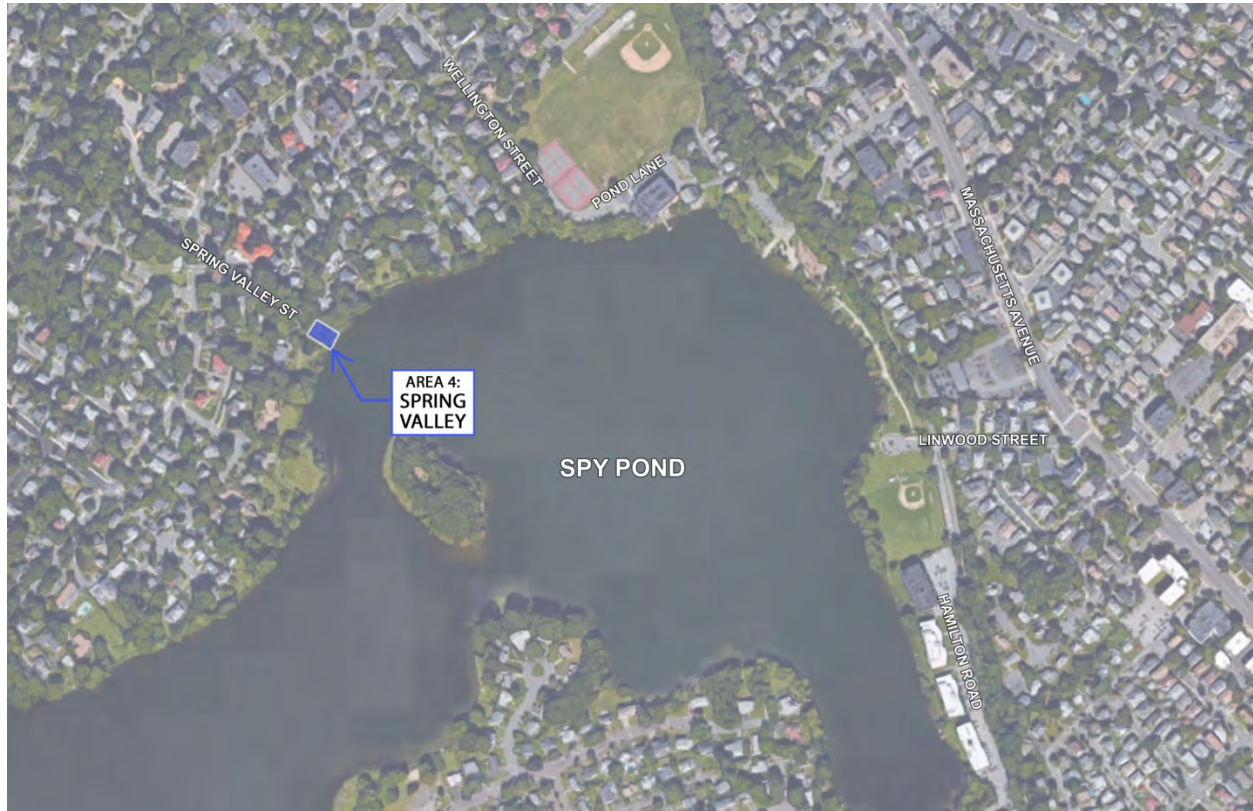
Figure 7 – Area 4: Spring Valley Street

A recent rainfall event that produced high energy sheet flow across the paved boat launch area at the end Spring Valley Road undermined and overturned a 30-inch diameter poplar tree that served to stabilize the bank adjacent to Spy Pond. The upturned, root ball, approximately eight feet in diameter has created a large, eroding crater in the slope at the water's edge. The fallen tree extends out into the pond for approximately 80 feet, supported by broken limbs.

This component of the project was part of a conceptual green infrastructure retrofit developed by Chester Engineers in 2014 in conjunction with a stormwater grant sponsored by Mystic River Watershed Association (MyWRA) and implemented through Arlington's Public Works Department. The concept was designed to divert stormwater runoff from the Spring Valley Street into a cascading bioretention channel leading to a small treatment wetland and from there into Spy Pond. It is situated at the end of Spring Valley Street, accessible by vehicle or on foot. The area currently serves as a small boat launch facility for surrounding neighbors.

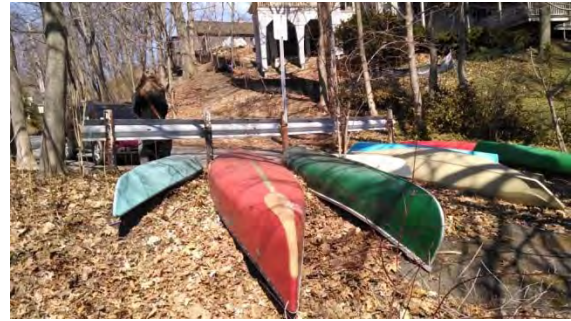
Photograph 15: Small Boat Launch Facility, Lower End of Spring Valley Street
